Inspection Report

Minerals Regulatory Program

Mine Name: Jumbo-Jensen Quarry	Permit Number: M/041/0008
Operator Name: United States Gypsum Company	Inspection Date: November 1, 2011
Inspector(s): Peter Brinton, Lynn Kunzler	Time: 2:00pm to about 3:30pm
Other Participants: Jeremy Taylor, US Gypsum	Mine Status: Active

Purposes of Inspection: To inspect areas recontoured in 2011

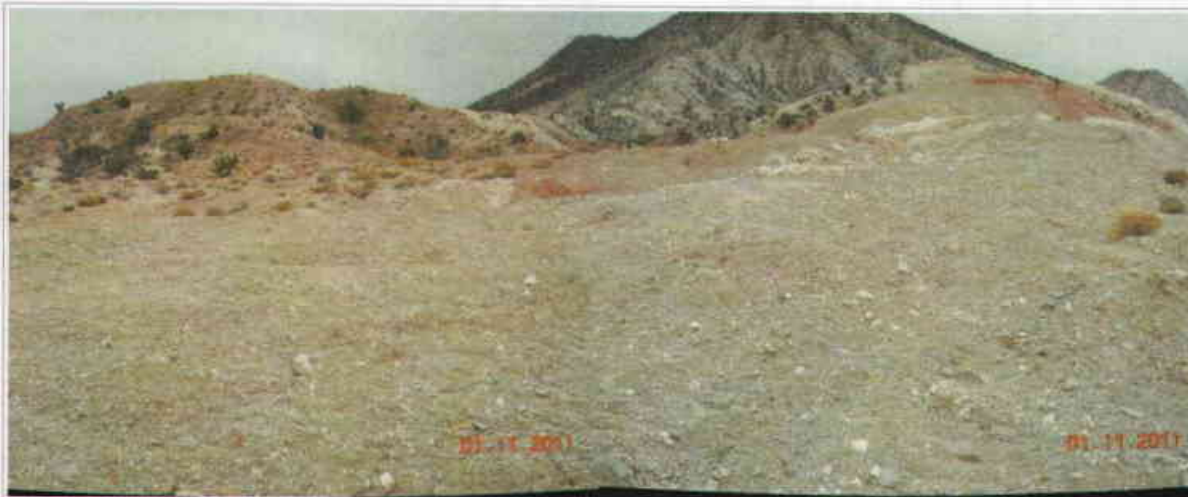
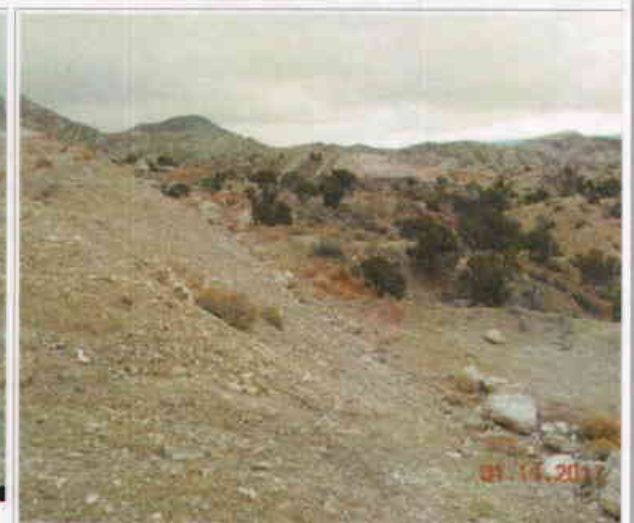
Parts of two recontoured areas (the Claw and 4A SE) were inspected. The recontouring work at 4A SE was found acceptable, and the Claw area needed additional dozer work near the crest of the slope. Characteristics of acceptable reclamation earthwork in this environment were discussed, including the need to minimize potential rockfall hazards while simultaneously maintaining equipment operator safety.

Acceptable recontouring of 4A SE (Stitched photo).

It is recommended that the Division partially release area 4A SE.
